Minerals Inspection Report

Report Date: 08/26/2014

Mine Name: South Farm	Permit Number: S/035/0030	Mine Status: Approved
Operator Name: R.A. Johnson	Inspection Date: 08/18/2014	Permit Fees: Paid
Inspector(s): L. Heppler	Inspection Time: 2:30 PM	Bond Amount: \$5,000
Attendee(s): Blake Thomas-Herriman, Robert Johnson-Opt	Weather: Sunny, Dry	Bond Escalation: 10/15/2010
Inspection Purpose: Operator requested bond release		Prior Inspection: none

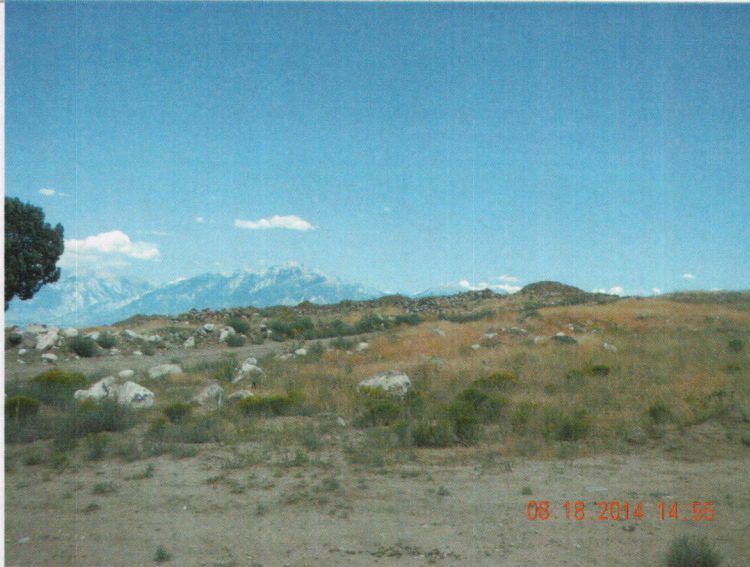
Access road from above

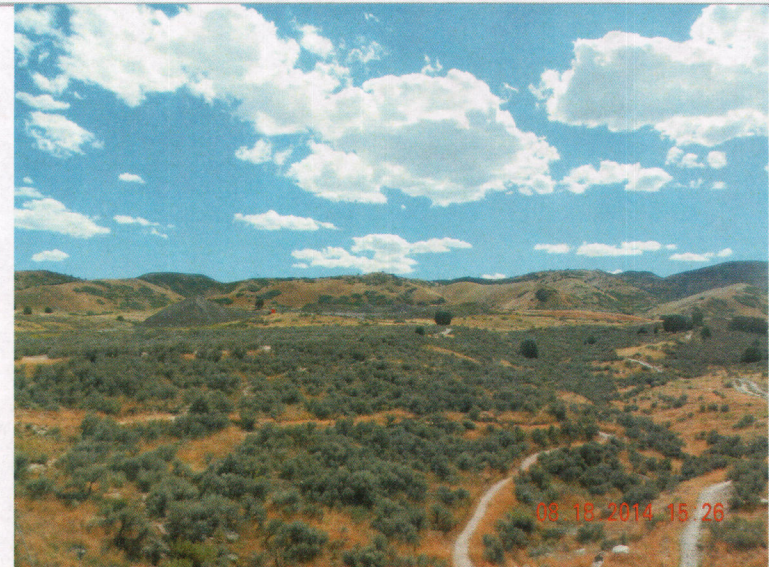
Mine site - photo taken from Mountain view corridor

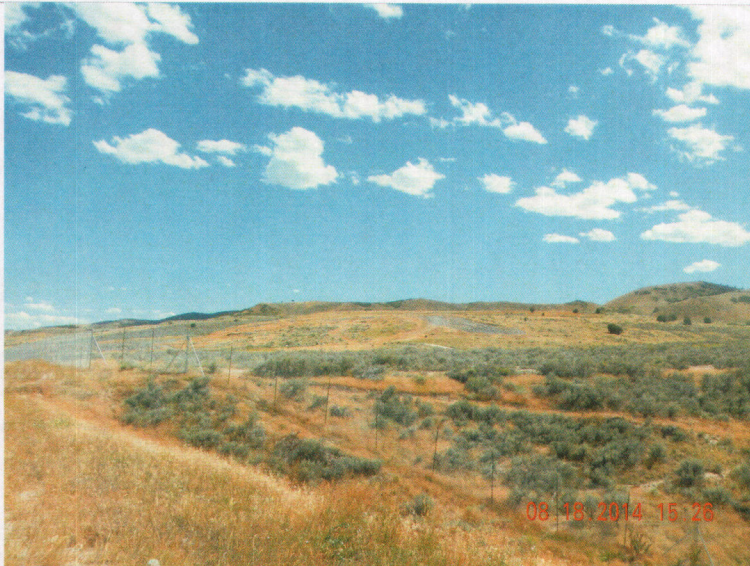
Mine site - photo taken from Mountain view corridor

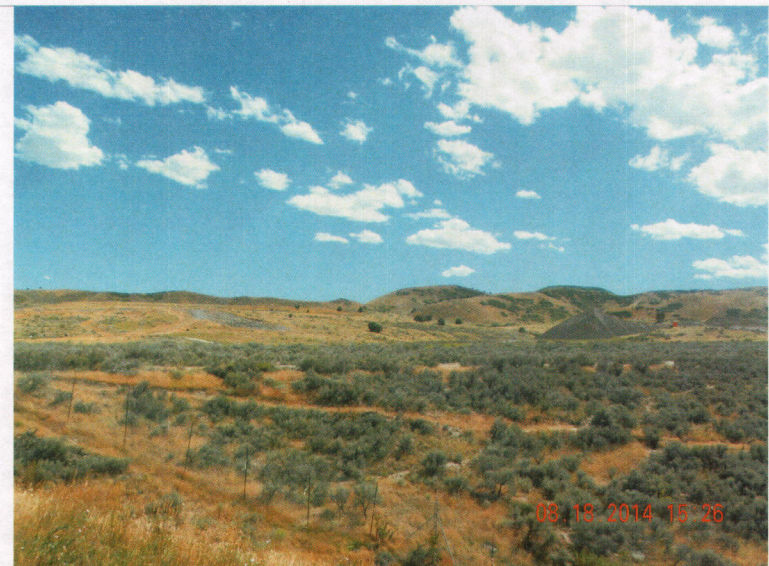
Mine site - photo taken from Mountain view corridor
